PHYTOTOXICOLOGY PRE-OPERATIONAL  
ASSESSMENT SURVEY  
IN THE VICINITY OF  
THE CANADA BRICK PROPERTY  
(FORMERLY MILTON BRICK)  
MILTON-AUGUST 16, 1990

PHYTOTOXICOLOGY PRE-OPERATIONAL ASSESSMENT SURVEY IN  
THE VICINITY OF THE CANADA BRICK PROPERTY (FORMERLY MILTON BRICK)  
AUGUST 16, 1990

Air Resources Branch  
Ontario Ministry of the Environment

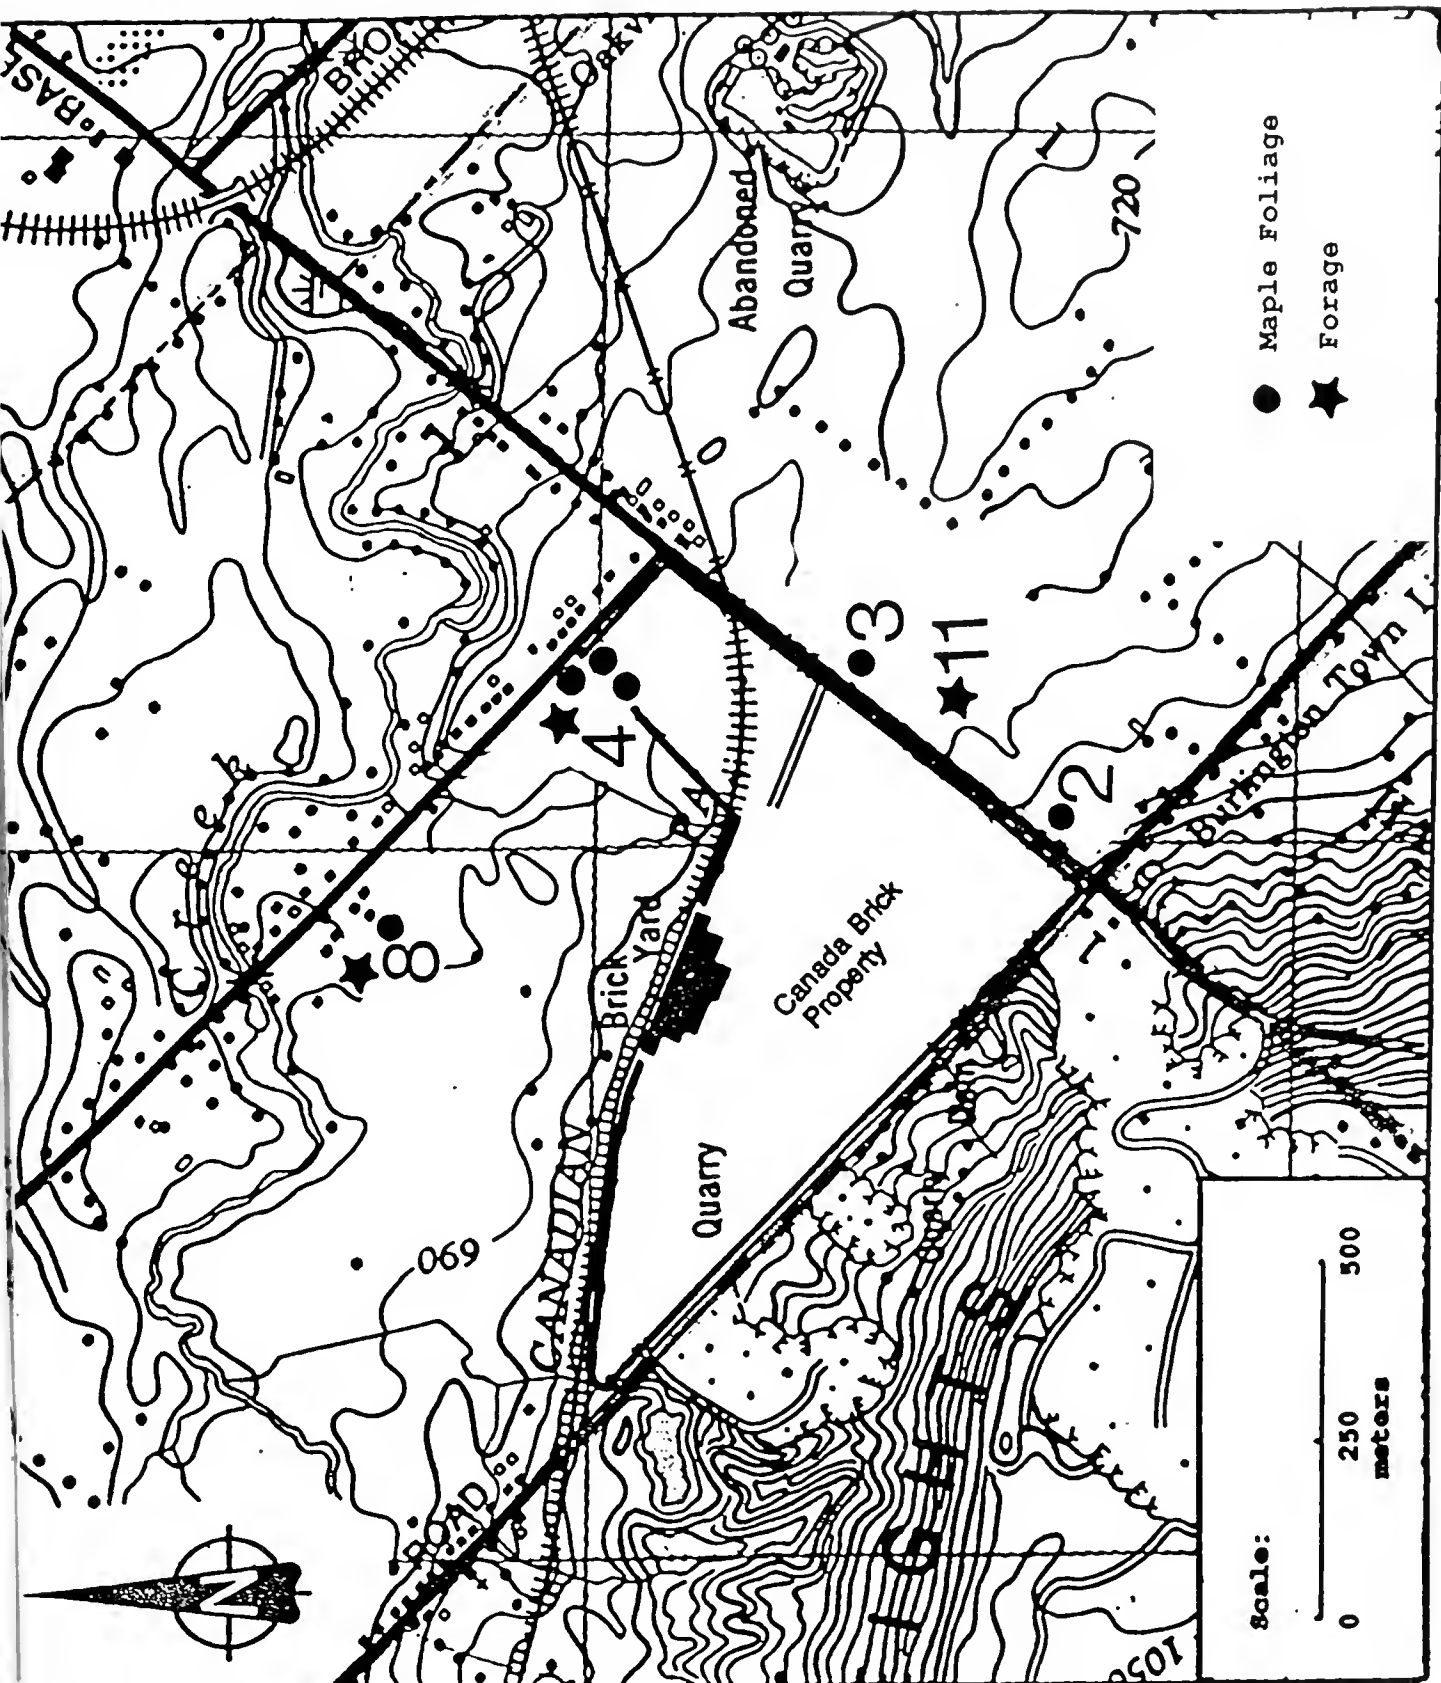
Map Showing Canada Brick Property, the Former Milton Brick Building and Vegetation Collection Sites - 1981 and 1990

Maple foliage and/or forage samples were collected from the 5 site areas sampled to the southeast, northeast and north of the plant site in 1981 (see attached figure). At each maple site, foliage was collected from exposed middle branches facing the Canada Brick property. At each maple and forage site, duplicate samples were collected, using standard sampling procedures. Also, during the survey, the maple collection sites and other vegetation were visually inspected.

\* Distance from the approximate centre of the old brickwork building (see figure)
